DETAILED STABILITY ANALYSIS ON A MAJOR SLIDE OCCURRED NEAR UYILATTI WATERFALL, KOOKALTHORAI TO KOTAGIRI ROAD, THE NILGIRIS DISTRICT, TAMIL NADU

ABSTRACT. Landslides threaten hill stations like Ooty in the Nilgiris district of Southern India due to their steep terrain, heavy rainfall, and anthropogenic activities like improper planning and deforestation. In December 2022, a major landslide occurred on the Kokalthorai to Kotagiri road near Uyilatti waterfalls in Kotagiri taluk, Nilgiris district, Tamil Nadu. A study has been initiated through a comprehensive slope stability analysis, and the research methodology incorporates a combination of geotechnical investigations and field surveys. The rock slope stability assessment used geomechanical analysis systems, specifically the Rock Mass Rating (RMR) and Slope Mass Rating (SMR). The type of failure and their Factor of Safety (FOS) for individual discontinuities in rock slopes were calculated using the Hoek and Bray method. The FOS was computed using a Circular Failure Chart (CFC) regarding soil slopes. A detailed field investigation was conducted to collect data required for RMR and SMR calculation. As per Hoek and Bray's Kinematic me

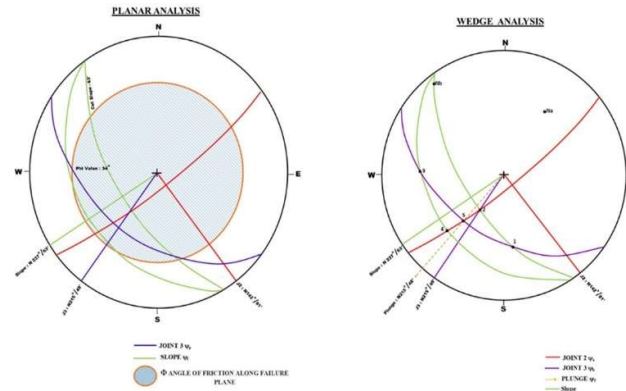
Figure 4 Stereonet analysis for Planar and Wedge Failure analysis

an artificial canal are observed, while on the lower slope, there is a tea plantation. The joints are exposed throughout the slope. J2 fulfills the planar analysis, with the discontinuity in the N142° dip direction and an inclination of 81° (Figure 4). The safety factor was calculated according to Hoek and Bray's equation 2. As per the planar analysis, the factor of safety for this slope is 1.583, 0.5260, 0.2455, and 0.1637 for dry, 50% saturation, 25% saturation, and fully saturated conditions, respectively. The calculations are shown in Table 6. Some rock falls have already occurred on this slope in 2022, and it is unstable in moderate to heavy rainfall.

The failure of a slope, wherein structural features that facilitate sliding run across the slope crest and sliding occurs along the line of intersection of two such planes, is termed a Wedge failure. This section is situated at 11°28'27" N latitude and 76°50'01" E longitude. Gneiss is prevalent in this zone, as identified during field investigation. Tension cracks or joints are visible in the upper slope, with three sets of joints, namely J1, J2, and J3, present in this slope. Joint 2 and Joint 3 fulfill the Hoek and Bray conditions for wedge analysis, as illustrated in Figure 4. The cross section of the slope presented in Figure 5. The plunge direction is N215°, and the dip is approximately 48°, nearly exposed in the cut slope. According to the analysis, the safety factor for the slope is approximately 0.4785, as detailed in Table 7. The safety factor is just below one, indicating an unstable slope.

implemented on the soil slope, and a suitable option that provides better results in terms of safety and stability will be suggested. Passive piles can stabilize the sliding mass above the failure surface and avoid planar and wedge failure. Rock bolts enhance the jointed rock mass in the J2 and J3 Sections. They are installing rock anchors to avoid moving along discontinuity joints. In conclusion, our study not only identifies potential instability in the analyzed sections but also proposes specific remedial measures tailored to the unique conditions of each area. The outcomes of this research provide a foundation for informed decision-making and the development of effective strategies for slope stability and landslide mitigation in the Kokalthorai to Kotagiri road region.

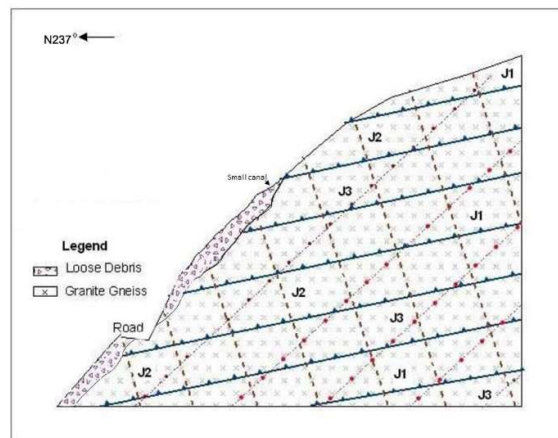
Figure 5 Cross-section of the slope

According to Markland’s test, a slope has a high probability of plane failure if it satisfies $\psi_s > \psi_p > \phi$. This rock section is located at 11°28’27” N latitude and 76°50’01” E longitude. The rocks are predominantly exposed, and highly jointed gneiss rock is present on this slope. The cut slope height is about 6m. Three sets of joints, J1, J2, and J3, are present in this slope. On the upper slope, a forest and
