**A Model Proposal for the Conservation of Rural Religious Heritage:  
Case of Former Bulgarian Exarchate Church in Seymen Village in Silivri Istanbul**

**Keywords:** Rural religious heritage, adaptive reuse, conservation model, Bulgarian Orthodox Exarchate Church, Istanbul.

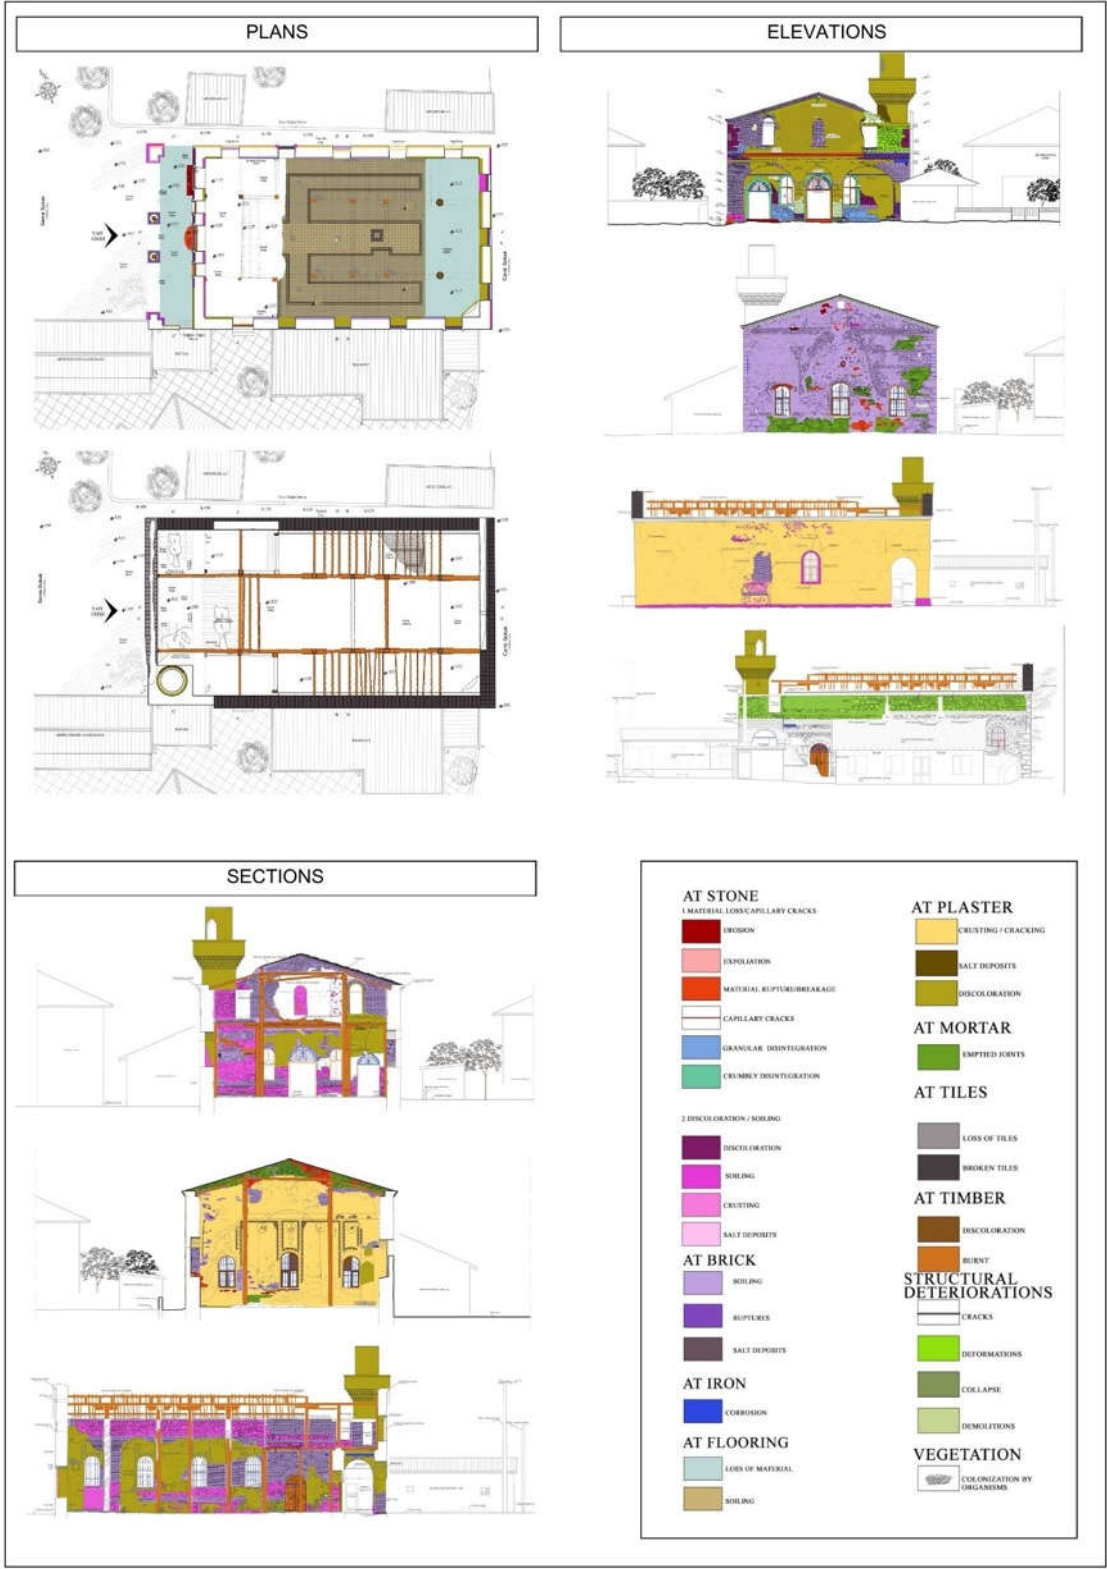
Figure 4. Materials and structural deterioration of the building (authors' archive).

This building experienced sudden and severe deterioration and the loss of many building elements and materials, primarily due to a fire in 2010. This building experienced sudden and severe deterioration, primarily due to a fire in 2010, which destroyed most wooden elements, including the timber roof structure, *mahfil*<sup>1</sup> floor, entrance doors, and window casings. The stairs on the southern side of the entrance were also burned. Two pillars near the eastern façade survived, but the others were destroyed. Today, 90% of the original floor covering of the main space remains, but the apse and narthex floorings are completely lost. The internal walls, built during the latter mosque period, were also destroyed during the fire, leading to accumulated debris inside the building. Additionally, the loss of the roof has left the interior exposed to external weather conditions (see **Figure 4**).

The building is also exposed to vegetation due to moisture from rain, as well as cracks, detachment, and chipping of the stones and emptied mortar joints, caused by repeated freeze and thaw cycle temperature fluctuations. Inside the building, the deterioration of the masonry materials mainly takes the form of blistering, cracking, erosion, exfoliation (either peeling, scaling, or flaking off), and detachment, as well as the spalling and crumbling of both the stone and brick. Such deterioration is the result of a lack of maintenance, presence of water, and weather conditions affecting the building materials (see **Figure 4**).

Discoloration of the stones is due to surface crust or efflorescence resulting from fire smoke, soiling, and salts. The replaced cement-based plaster is incompatible with the original construction materials and causes efflorescence due to the crystallization of salts. Mortar loss is also visible in the lower parts of the frontal columns.

All iron elements in the building have rusted due to direct exposure to weather. Apart from these, the effects of vandalism damaging the masonry structure can also be seen, where walls have been carved or hollowed out at specific points (see **Figures 4 and 5**).

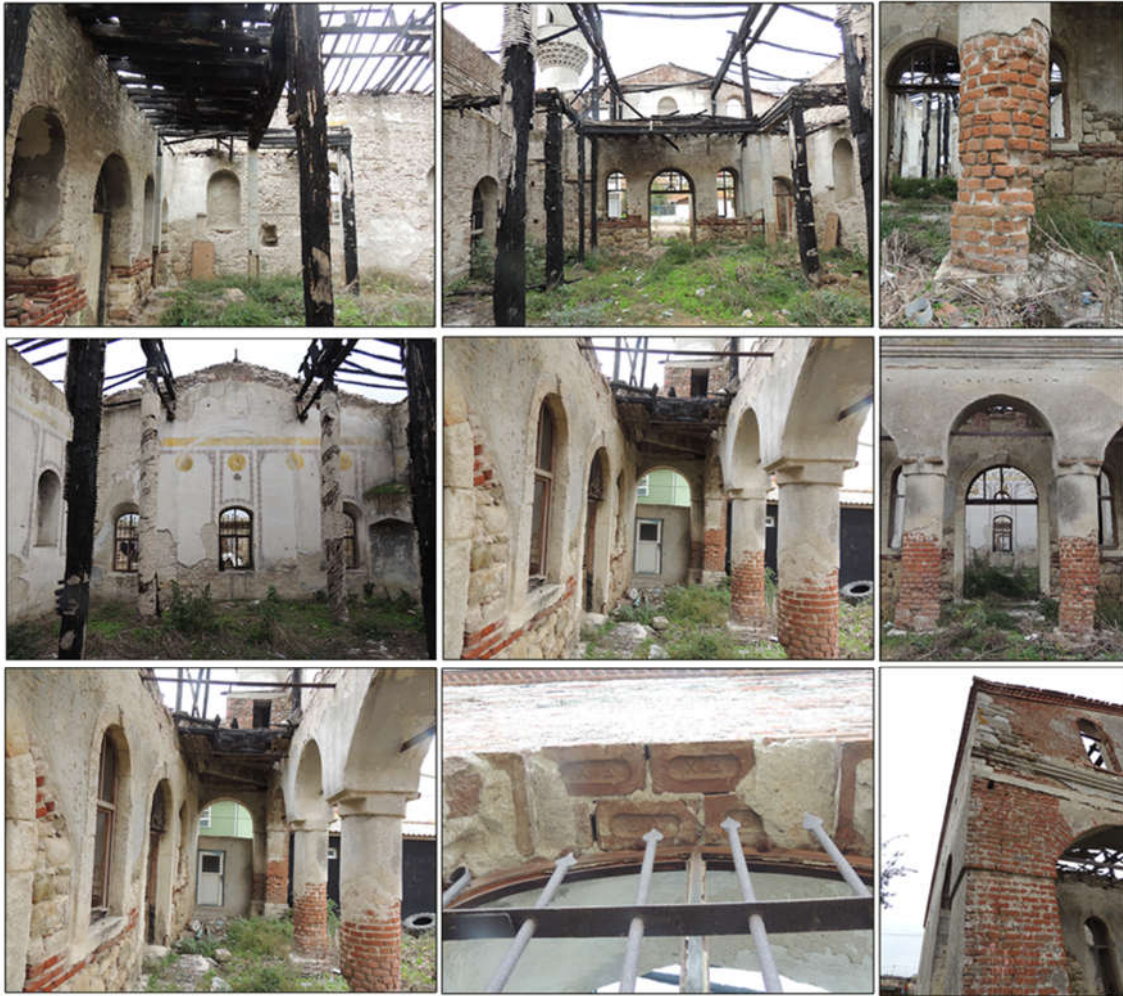
**Figure 5.** Physical condition of different parts of the building (authors' archive).
